Thermal Stain Improvements at Reversing Cold Mills

This paper focuses its analysis on the reversible cold mill No. 3 located at Planta Guerrero (today operated by Ternium México). The machine is a Bliss Machine LTD that started operation in 1978. During its first years, the mill focused on the manufacture of material that

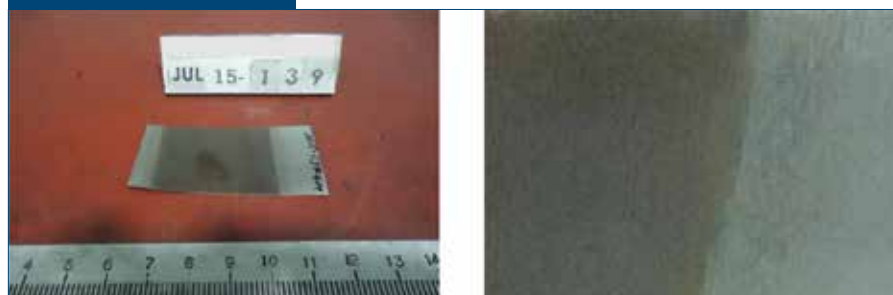
Figure 1

Thermal stain sample – macroscopic appearance.

The thermal stains can be observed by the naked eye after being cold reduced (in this case, stains were characterized in the cleaning line). They were detected in both sides and randomly across the width and length; stains could cover the entire width, and could be presented as strips, lines or dots. The thermal stains have an elongated morphology (generally in the sense of rolling),

with shades ranging from blue to dark brown, and occur in irregular sizes. They are also known as oil stains at Ternium.

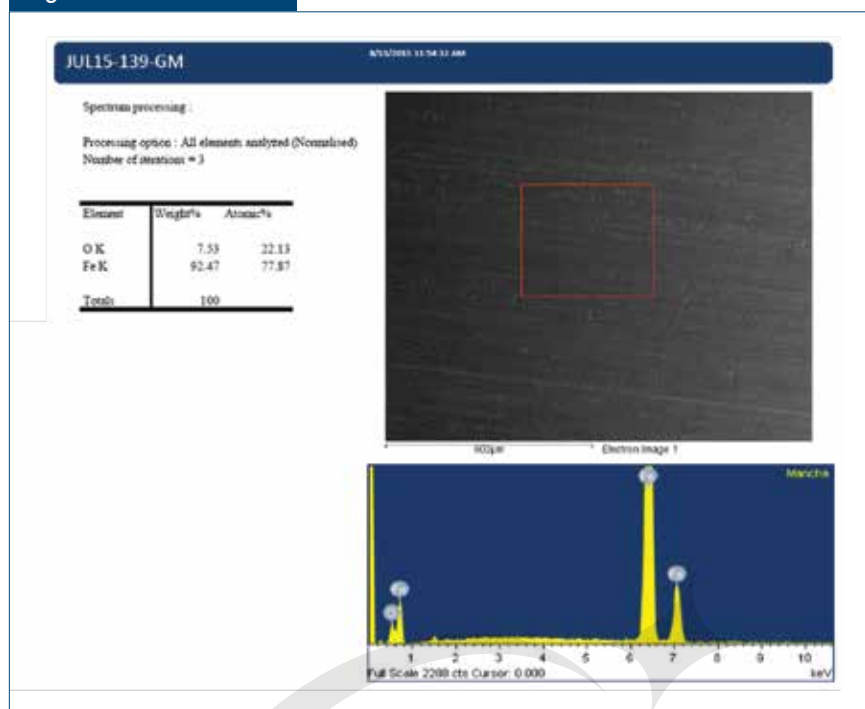
Figure 2

Thermal stain sample – microscopic appearance.

From a microscopic point of view, thermal stains are thin layers of iron oxide ($<1 \mu\text{m}$). Because of the thickness of the oxide layer, it was not possible to prepare a sample large enough to analyze the cross-section of the stain. However, the following figures show how, using the scanning electron microscope and x-ray diffraction analysis in the defect area, slight iron formations could be observed. In the defect area,

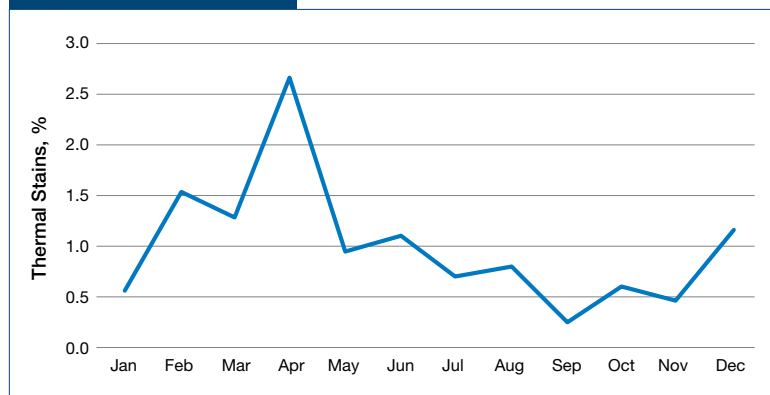
Figure 3

Thermal stains declassified material (2015).

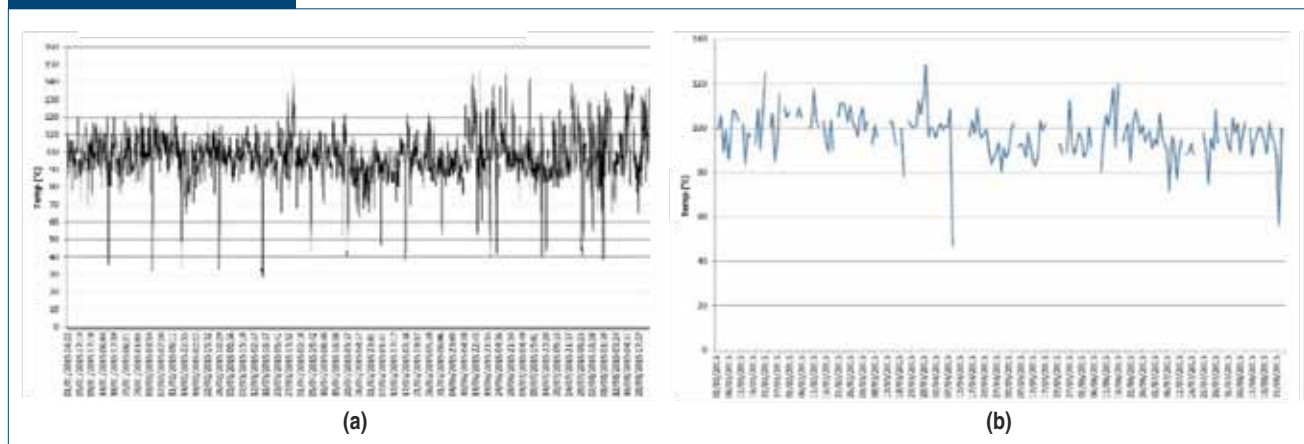
Figure 4

Coil temperature: all products (a) and 26 and 29 gauge (b).

After correlating the MF3 coiling temperature versus the intensity of the defect revealed by the inspection at the cleaning line (batch annealing routed), it was observed that for coils wrapped in temperatures lower than 80°C , defects logarithmically decreased. That is why this paper's main objective became controlling any source of coil temperature increase and maintaining winding temperatures below 80°C . The first steps were to adjust and correct the header configuration and nozzles.

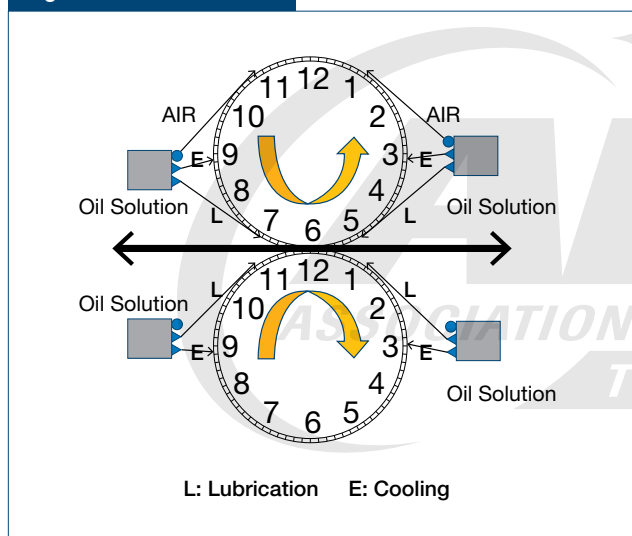
Figure 5

Headers (air/solution) configuration.

the work rolls. To do this, the appropriate configuration (nozzles according to prints) and geometry of the emulsion heads (Fig. 5) were revised. The emulsion flow was increased by applying the four headers in the last two passes (changing work instructions) and achieving at least 2.5 bar at headers due lower pressures, which means lower impact angles toward the work rolls and therefore less coverage area for cooling and lubrication.

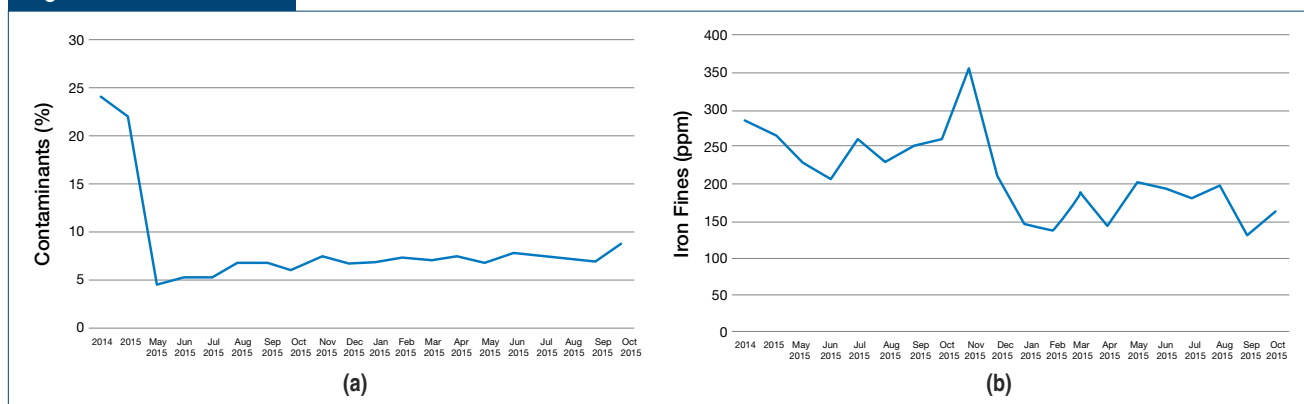
Figure 6

Oil solution: contaminants (tramps) (a) and iron fines (b).

Vacuum filter (Hoffman) was checked for vacuum capacity, specifically filter paper specification. Paper filtering capacity was adjusted to 10 microns (from 50 microns to 40 microns). Fig. 6 shows a contamination and iron fines concentration chart, and how they were impacted by the actions taken. In this, sense not only is the condition of heavy oils and iron fines the emulsion improved, but less corrective maintenance (such as skimming) or partial change of emulsion are required, which translates to savings in oil consumption.

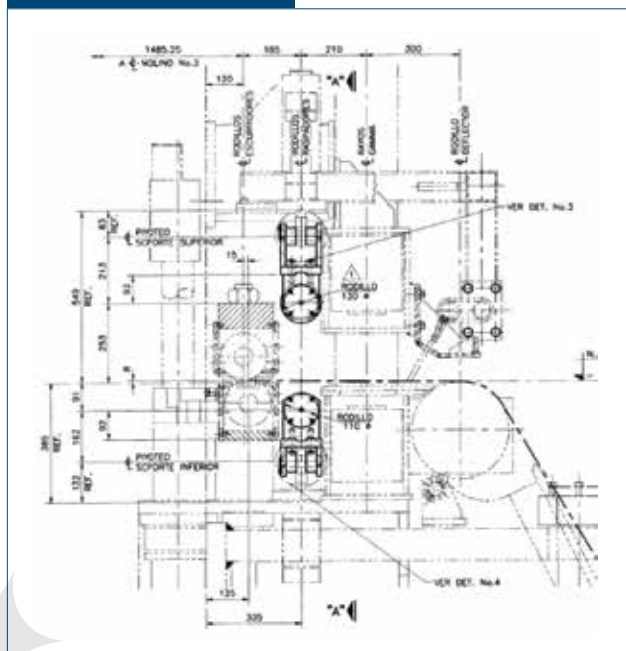
Figure 7

Roll configuration in the exit section.

Carryover — The amount of solution that is dragged and subsequently rolled up (humidity) is the last piece to be controlled in order to break the corrosion cycle described earlier. During the development of this paper, two important actions were taken to reduce/eliminate solution carrying over. As seen in Fig. 7, there are two barriers designed to stop the emulsion carryover: squeegee rolls and scraper rolls. In both cases, the mechanisms were rehabilitated in order to improve the application pressure; in addition, the material of the upper scraper rolls was modified from hypalon to a compound with greater draining capacity.

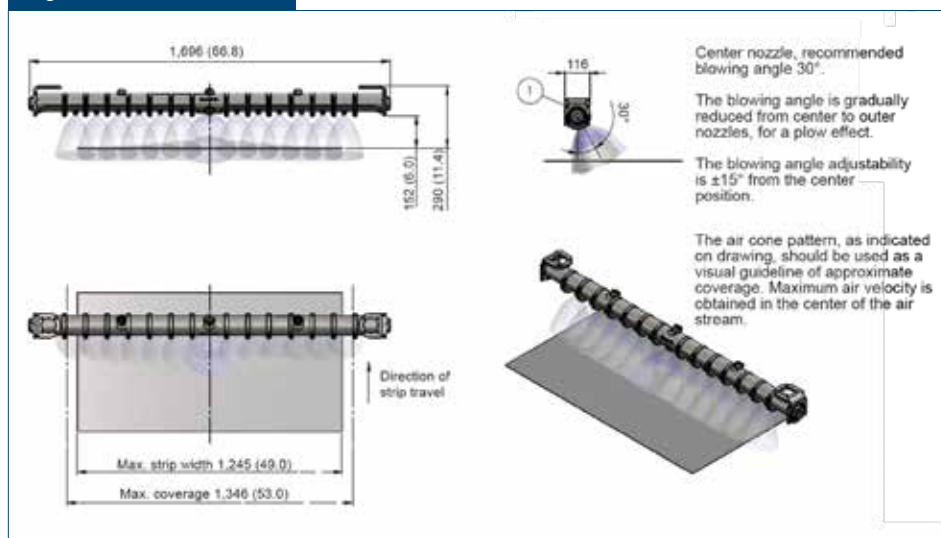
Figure 8

Air headers.

Finally, air headers with greater sweeping capacity (higher speed) using special nozzles were designed and installed. These headers not only ensured the proper sweep, but also decreased noise generation in the area and saved air consumption.

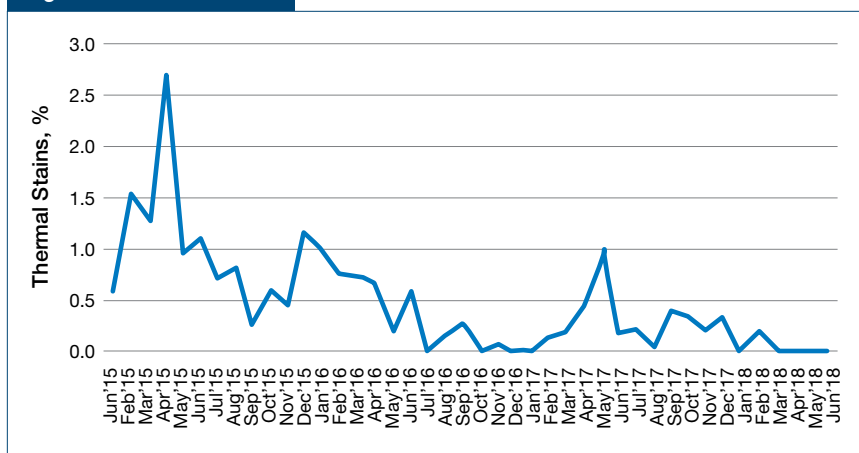
Figure 9

Thermal stains declassed material (2015–2018).

(less amount of fines iron and tramps reduction of heavy oils and grease) and (3) carryover sweeping. As shown in Fig. 9, thermal stains average generation is less than 0.5%. Additionally, due to the change in technology in the sweeping air header, an improved noise generation of 10 dB and a 750 scfm decrease in compressed air consumption were also realized.
